**Creak From the Right Side of the Dash**

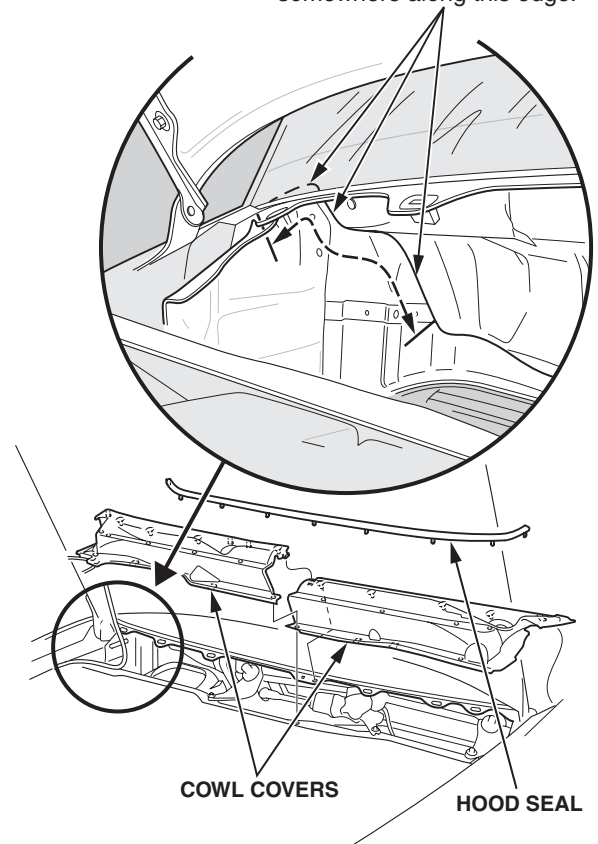
The creak is happening somewhere along this edge.

2. Remove the hood seal and the cowl covers.
