Applies To: **2007 Element With 2WD** – From VIN 5J6YH1...7L000001 thru 5J6YH1...7L007749
2007 Element With 4WD – From VIN 5J6YH2...7L000001 thru 5J6YH2...7L005730

Front Passenger's Seat Base Cover Is Loose

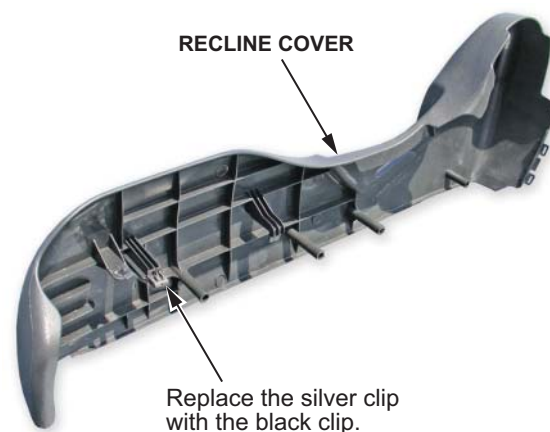
1. Remove the recline cover:
 - Refer to page 20-108 of the *2007–2008 Element Service Manual*, or
 - Online, enter keywords **FRONT SEAT**, and select **Front Seat Cushion Cover Replacement** from the list.

2. Inspect the cover for damage:
 - If the cover is not damaged, replace the silver trim clip with a new black clip, and reinstall the cover (*do not replace it*).
 - If the cover is damaged, replace it (it already has the new clip attached).
