Applies To: 2003–05 Element – ALL

2006 Element 2WD – From VIN 5J6YH1...6L000001 thru 5J6YH1...6L007635 **2006 Element 4WD** – From VIN 5J6YH2...6L000001 thru 5J6YH2...6L012681

Element: Driver's Seat Rocks

(Supersedes 03-032, dated June 25, 2004, to update the information marked by the black bars)

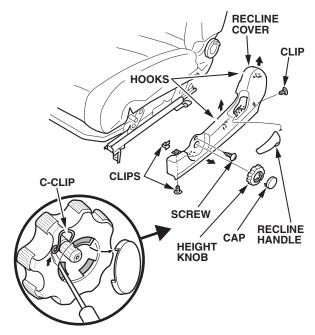
- 1. Make sure you have the anti-theft code for the radio, then write down the frequencies for the preset buttons.
- 2. Disconnect the negative cable from the battery, and wait at least 3 minutes before beginning work.
- 3. Remove the driver's seat from the vehicle.
 - Refer to page 20-86 of the *2003–06 Element Service Manual*, or
 - Online, enter keyword **SEAT**, and select **Front Seat Removal/Installation** from the list.
- 4. Place the seat on a workbench covered with shop towels.
- 5. Pull off the recline handle.

- 6. Pry the center cap from the height knob with a flattip screwdriver. Remove the C-clip, and pull off the knob.
- 7. Remove the recline cover (one screw, three clips, and two hooks).

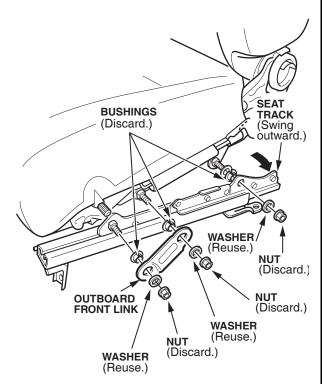
8. Remove and discard the three nuts. Remove and retain the washers from the outboard front link and from the seat track. Remove and discard the three bushings.

9. Install the three new bushings and the outboard front link.

10. Use brake cleaner to remove grease from any threads before installing the nuts.

Install the original washers and new nuts. Torque the nuts to 22 N·m (16 lb-ft).

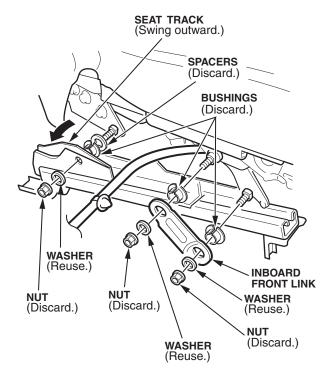
NEW SPACERS

12. Remove and discard the three nuts. Remove and retain the washers from the inboard front link and the seat track. Remove and discard the three bushings. Remove and discard the spacers between the seat and the seat track.

13. Add the three new spacers to the rear mounting stud.

- 14. Install the three new bushings and the inboard front link.
- Use brake cleaner to remove grease from any threads before installing nuts.
 Install the original washers and new nuts. Torque the nuts to 22 N·m (16 lb-ft).
